The root cause of a shaft crack

by **Don Silcock**
Bently Nevada Corporation

Shaft crack shuts down plant

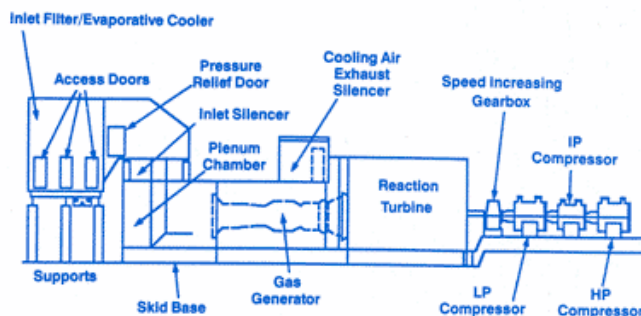
Figure 1

The Synthesis Gas Compressor train is unusual. It does not use a steam turbine driver. Instead, it is driven by a gas generator exhausting into a reaction turbine. The reaction turbine drives three "barrel type" compressors, through a speed-increasing gearbox.

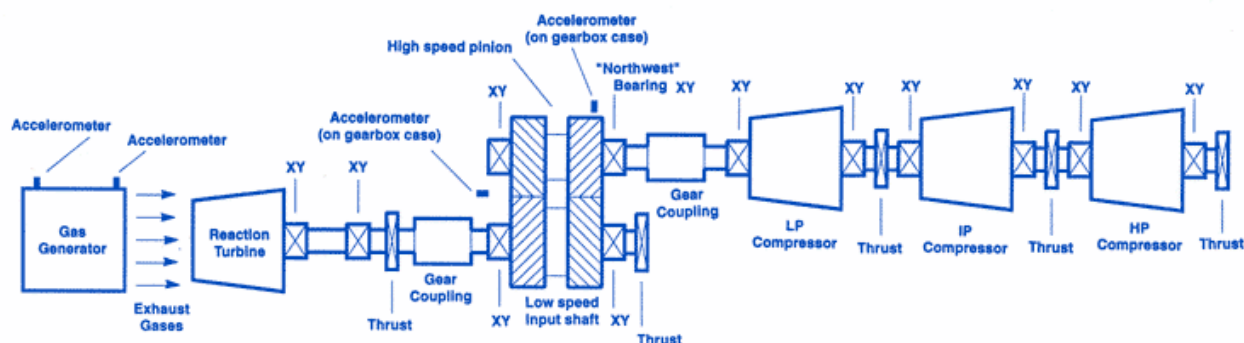
Figure 2

Machine train diagram showing transducer placement.

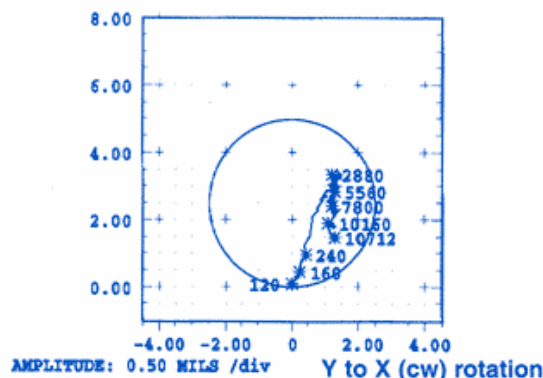
Figure 3

Obviously, the reaction turbine, gearbox and LP compressor had not been correctly aligned. This was clearly shown in TDM2 average shaft centerline position plots, of the gearbox "northwest" bearing and the LP compressor drive-end bearing.

In a machine with fluid-film bearings, such as this, the rotor normally rises on an oil wedge as it gains speed. At operating speed, a shaft rotating Y to X (cw) with no abnormal load will usually be in the lower left quadrant of its bearing. It is clear from Figures 3 and 4 that the rotor is abnormally loaded, because of the atypical operating positions.

Shaft centerline plot, showing movement of the gearbox high speed pinion in the "northwest bearing" during machine startup.

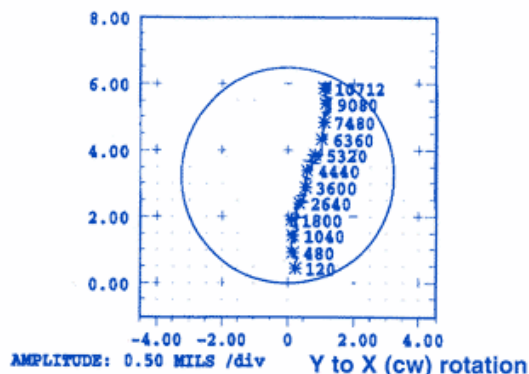
Figure 4

Shaft centerline plot, showing the shaft movement at the drive end bearing of the LP compressor during machine startup.
